JAVELINA HEIGHTS

1258 Blake Ave
Payson, AZ 85541

PREPARED BY:
GENERIC ENERGY CONSULTING

Generic Energy Consulting, INC (GEC) conducted an energy and water audit for Javelina Heights Apartments in Payson, AZ. A site visit was conducted on November 1, 2023. This report has the following purposes, summarized below:

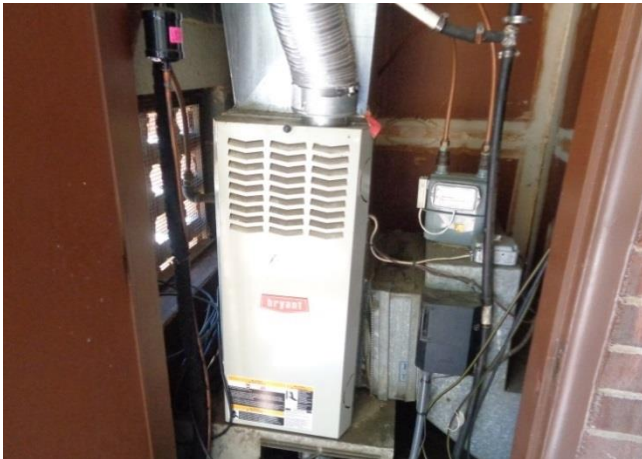
Figure 6: Typical Furnace in Apartments

2. The furnaces and condensing units which heat and cool apartments are inefficient and approaching the end of their useful life.
3. The domestic hot water piping that serves the apartments is uninsulated in central mechanical rooms. This situation results in heat loss through the pipes.

Improvement Summary:	Install high efficiency heat pumps (minimum 10 HSPF, 16 SEER) in apartments to replace existing furnaces and AC units. Equipment must be ENERGY STAR-certified.
Benefits Attained:	While replacing heating and cooling units for apartments is an expensive measure, many of the units will need replacement in the coming years as they are reaching the end of their useful life. Replacing now with high efficiency alternatives provides significant cost savings and comfort benefits and reduces large future capital expense.
Assumptions:	To calculate heating and cooling savings, we assumed an improvement in efficiency from 75% AFUE to a HSPF of 10 for heating and from 12 to 16 SEER for cooling units. We used existing system specifications and historical fuel usage data for heating and cooling to calculate the estimated run-hours for existing equipment and true-up to existing utility consumption.

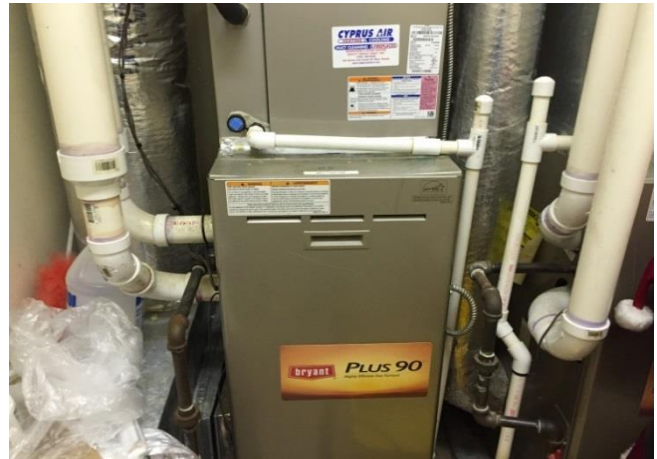
Figure 8: Typical Condensing Unit for Apartments

Cooling to units is provided by a dedicated condensing unit. The air conditioning system tempers the outdoor air to provide conditioned air to the space based on the thermostat settings. The condensing units serving the apartments have a 2-Ton cooling capacity and use R-22 refrigerant. Due to their lower efficiency, these units should be replaced.

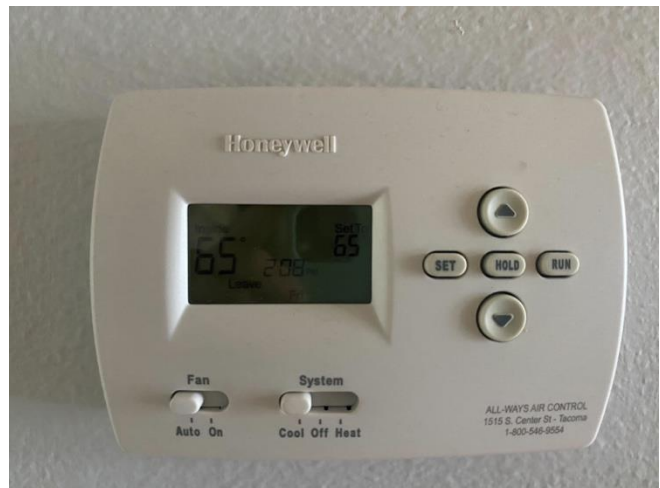
Figure 9: Typical Thermostat in Apartment

1. The furnaces in the apartments are controlled using programmable thermostats. There are opportunities to upgrade existing programmable thermostats to smart thermostats.

A dedicated thermostat is installed in the common spaces in the apartments to control heating and cooling. The thermostat allows the occupant to choose the mode of conditioning and choose a temperature setpoint. The existing thermostats have simple programming capabilities.

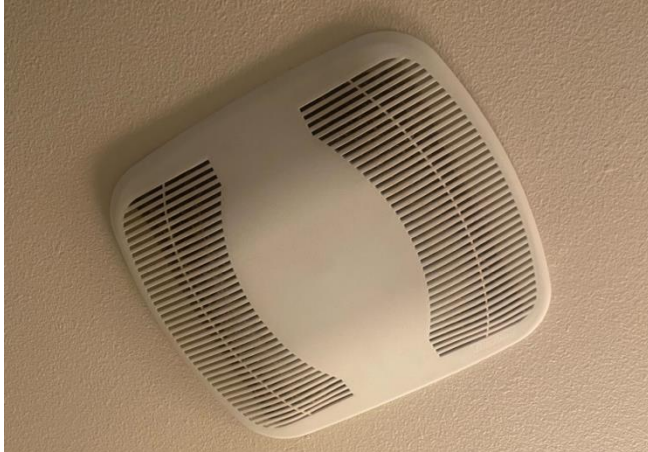
Figure 10: Typical Exhaust Fan in Apartment Bathroom

Ventilation: Apartment kitchens and bathrooms are ventilated mechanically. Each bathroom is equipped with a ceiling-mounted exhaust fan. Each kitchen is equipped with a ductless range hood. The ventilation systems are intermittent and turn on when the residents turn the switch on.

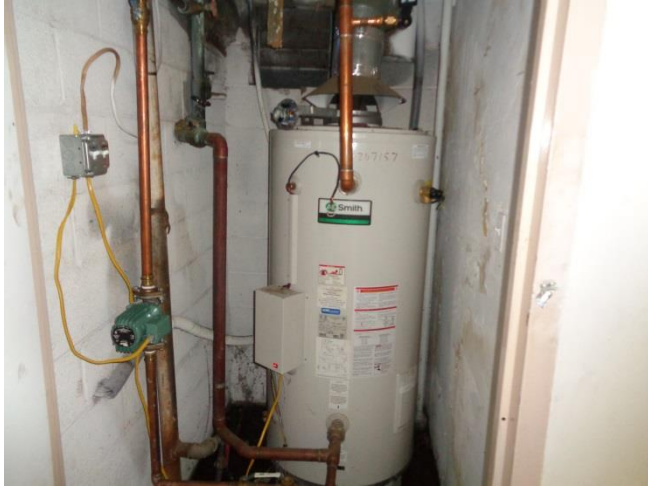
Figure 14: Typical Domestic Hot Water Heater

Eight (8) natural gas water heaters with integrated storage tanks provide domestic hot water (DHW) to the apartments. These heaters are located in eight (8) different locations and have a combined input capacity of 300,000 BTU/hr. A natural gas-fired water heater with an input capacity of 78,000 BTU/hr serves the rental office building. The heaters are controlled based on a hot water temperature setpoint. The temperature setpoints observed during our visit appeared to be appropriate for the property and hot water was measured in units at reasonable temperatures. A recirculation pump serves each heater to ensure hot water is available at all fixtures.

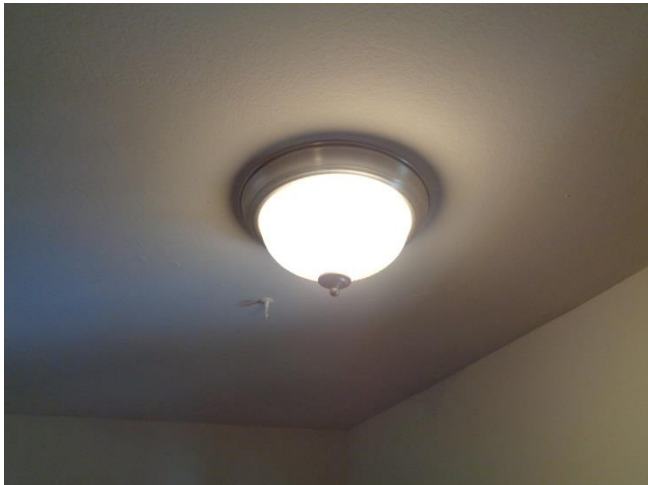
Figure 18: Typical Apartment Fixture

Owner installed and maintained fixtures in the apartments include fixtures with incandescent bulbs in the kitchen, apartment entrance, and bathroom. The facility maintenance staff has been replacing burnt out bulbs with CFL lamps in the kitchen and living room fixtures.

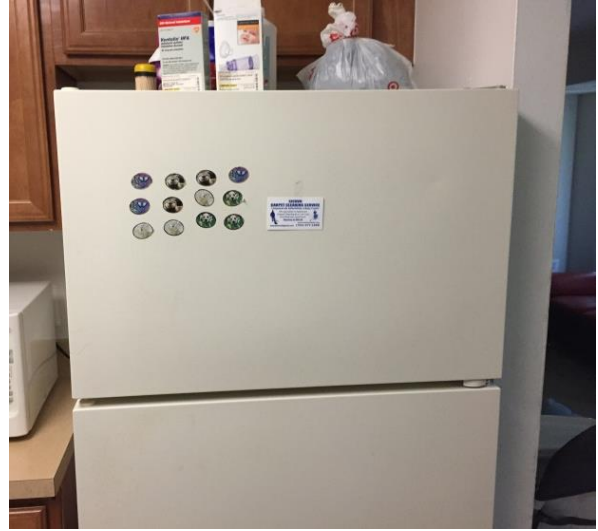
Figure 21: Typical Apartment Refrigerator

The apartments at the property are each equipped with a refrigerator, a dishwasher, a natural gas stove, and a natural gas oven. The refrigerators throughout the property vary in age and annual consumption. Based on our in-unit survey, all of the refrigerators warrant replacement. During our site survey, we conducted tests on a sampling of in-unit refrigerators. According to the sample set and discussion with the property staff, approximately 70% of the refrigerators are not ENERGY STAR-certified and some refrigerators are over 10 years old. The existing refrigerators use considerably more energy than ENERGY STAR-certified equivalents.

Install 129 new ENERGY STAR-certified refrigerators in place of the existing inefficient refrigerators. A full assessment shall be conducted to determine the proper sizing and replacement schedule.

Refrigerators shall possess top-mounted freezers and be appropriately sized. Ice-maker and dispenser models are not recommended because they use 15% more energy than standard ENERGY STAR-certified refrigerators and will increase the purchase price.

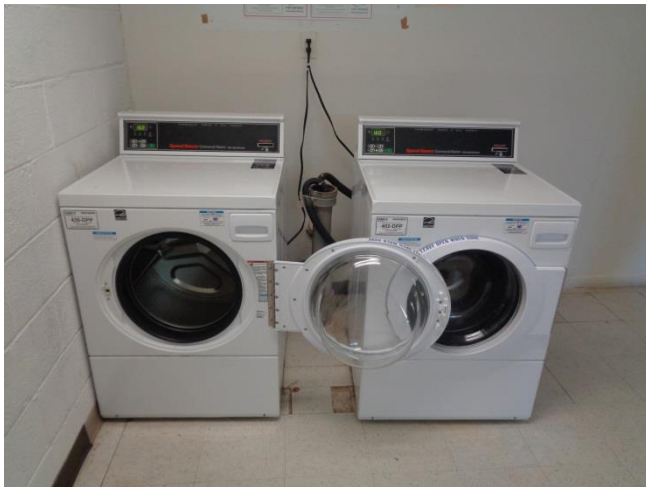
Figure 22: Typical Common Area Washers

Laundry service at the property is provided through dedicated leased laundry equipment in the property’s laundry facility. Based on the age of the equipment, they do not warrant replacement. The dryers use natural gas.

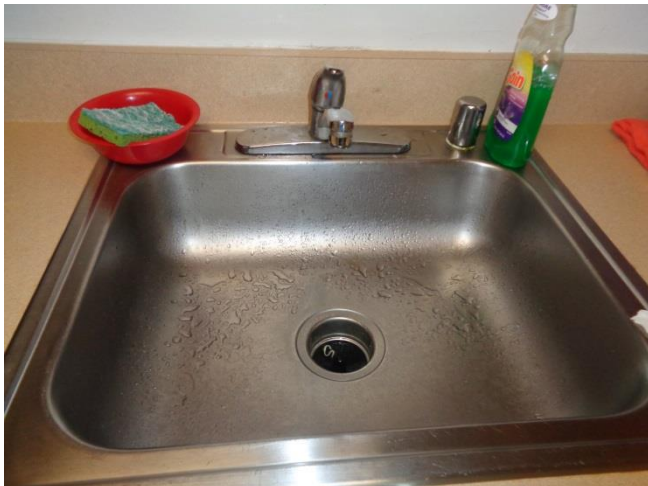
Figure 24: Typical Kitchen Sink

GEC found the plumbing fixtures in all sampled apartments to be identical. The kitchen and bathroom faucets are rated at 2 gallons per minute (GPM) but their average flowrates were measured by GEC to be 2.4 GPM and 2.04 GPM, respectively. The showerheads are rated at 2 GPM, but the average flowrate was measured to be 2.25 GPM. The toilets in the apartment are rated to flush 1.6 gallons per flush but were measured to flush about 2.54 gallons per flush, which contributes significantly to the high water usage at the property. A sample of volumetric flowrates at the faucets and showerheads as well as toilet flush rates can be found in the Exhibit D.

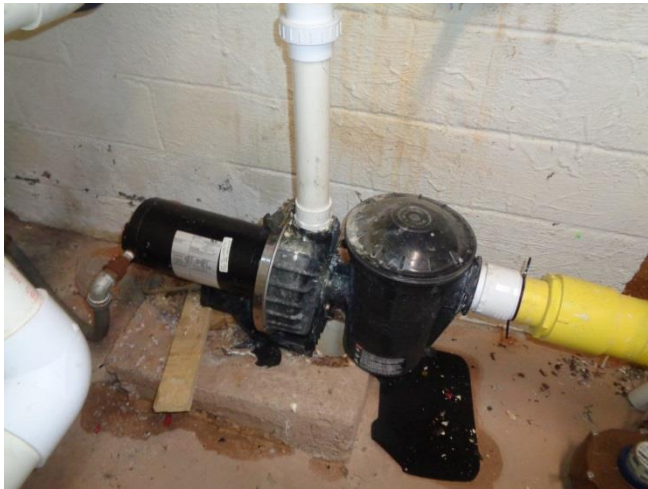
Figure 26: Pool Pump

7. The property has a pool that is open to residents during the summer. The pump serving the pool operates at constant volume, which results in excess consumption of electrical energy.

Swimming Pool: The property houses a non-heated, outdoor swimming pool located behind the rental office building. The pool is open from Memorial Day weekend through Labor Day weekend. A single 5-HP pump circulates water through the pool and operates on constant flow.

GEC recommends replacing the existing 5-HP continuous-speed pool pump with a variable frequency drive (VFD)-controlled pool pump. VFDs will take advantage of the varying pool water circulation demand to reduce the speed of the pool pump. The drive allows the pump to unload, which saves energy by delivering only the amount of water required by the operating heat pumps.

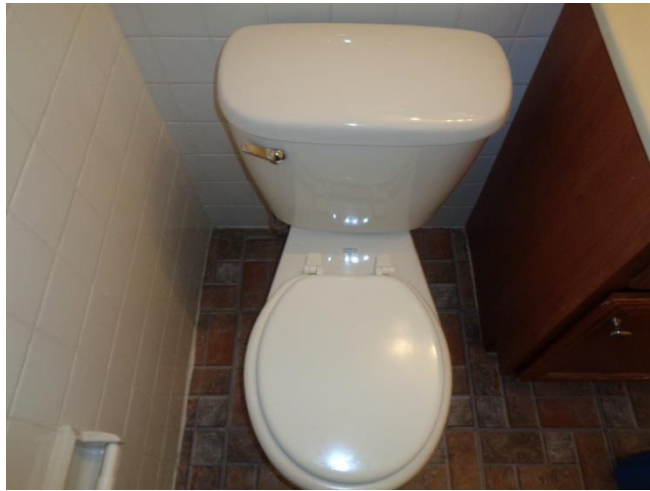
Figure 28: Typical Existing 1.6 GPF Toilet

Assumptions:	GEC modeled water savings as a reduction in toilet flow rates per flush from the average flow rates measured on site to the recommended flow rate, specified above. GEC assumed that toilets are flushed five (5) times per day per occupant and 100% of the toilets will be replaced.

Improvement Summary:	<p>Replace 235 existing toilet fixtures with 0.8 GPF pressure-assisted toilets. Pressure-assisted toilets are hybrids of gravity and flush-valve toilets. A pressurized tank, placed inside the porcelain tank, compresses a pocket of air and releases pressurized water into the bowl and out the trap way at high velocity, creating a vigorous flushing action that whisks away waste and cleans the bowl. The flushing action of these toilets is quieter than common pressure-assisted toilets.</p> <p>GEC observed that the piping configuration at the property should allow for 0.8 GPF toilets to be installed without extensive replacement of plumbing. An experienced plumbing contractor should be engaged to assess requirements prior to installation.</p>
Benefits Attained:	<p>Replacing old model toilets with new low-flow toilets will immediately reduce the water consumption at the property. Water-efficient pressure-assisted toilets also reduce the pressure demand on the water supply. These toilets require less maintenance because they have fewer moving parts.</p> <p>Moreover, with a pressure-assisted system, the flush water is contained in a plastic tank inside the ceramic tank, which eliminates the potential for condensation (sweating) on the outside of the tank. This design prevents water from dripping onto the floor, which may result in mold growth and damage to the flooring.</p>

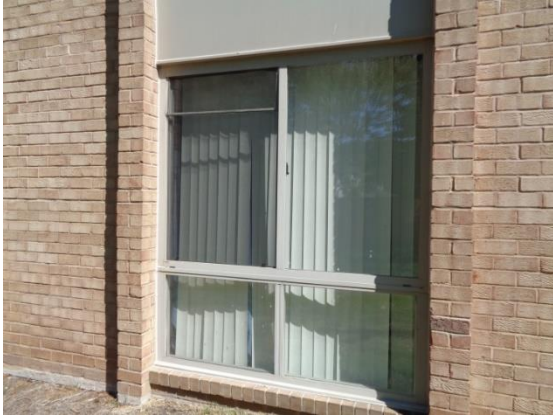
Figure 34: Typical Window in Apartments

Exterior Windows and Doors: The majority of the windows at the property are sliding type with double pane glass and ½" air gap. The windows appear to have functional weatherstripping and appeared to allow minimal draft through them when closed. All windows have aluminum framing with a thermal break.

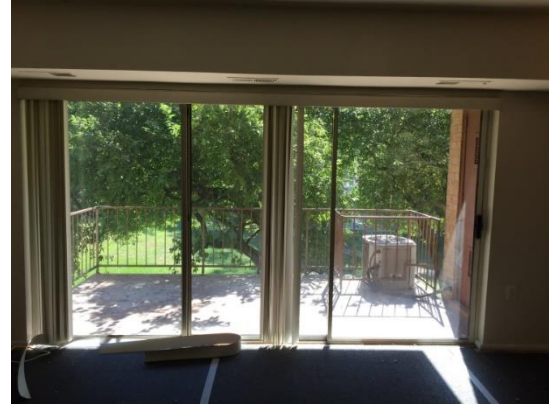
Figure 35: Typical Balcony Door

Each residential building at the property has one (1) main door for residents to access the building. These doors are made of wood and have a wooden frame. The doors appear to have functional weatherstripping. All the apartments at the property have sliding doors that provide access to a balcony or a patio. During the in-unit survey, we observed that the majority of the doors in the apartments have functional weatherstripping and appear to have minimal infiltration into the apartments.

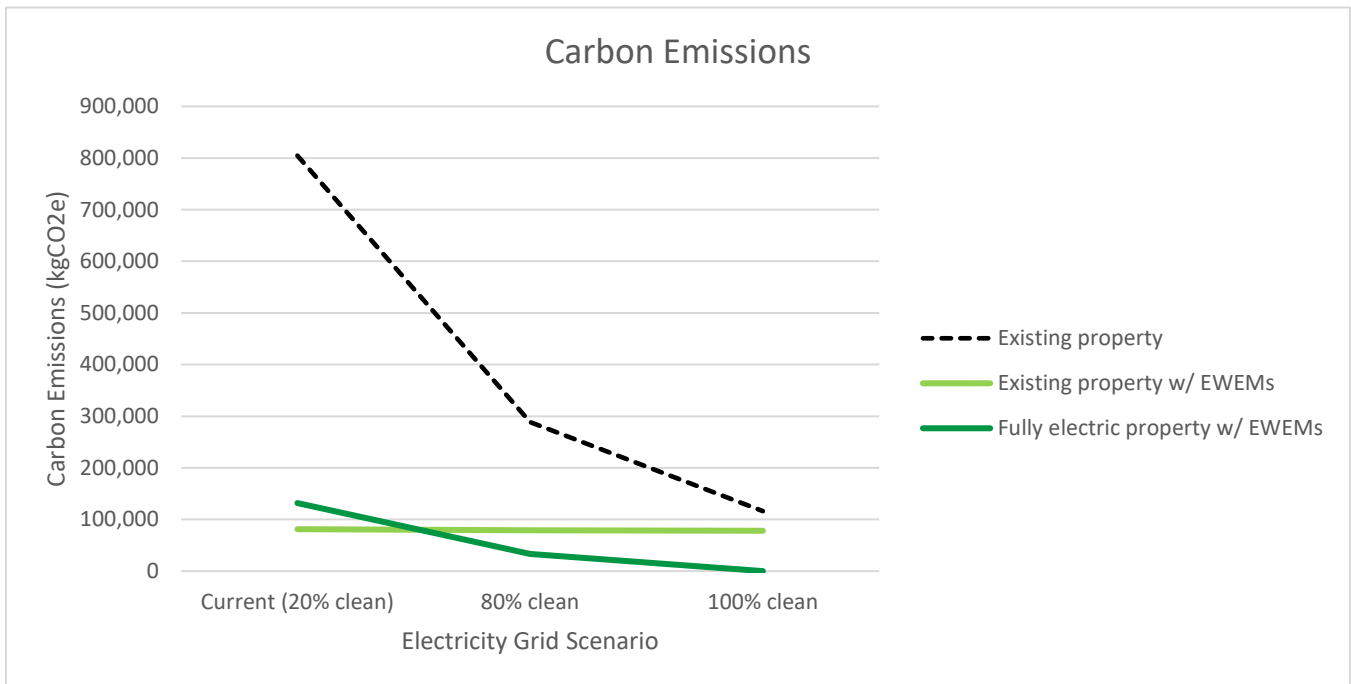
Figure 36. Modeled impacts.

The chart below compares estimated carbon emissions of the property's as-is energy use and equivalent all-electric energy use with all recommended EWEM upgrades, according to national clean grid scenarios targeted in the next 15 years. The "fully electric" property includes an assumed efficiency gain for replacing on-site fuel combustion (80% efficient) with electricity (100%), however, efficiencies as high as 300% can be achieved with heat pump technology.

Note: The "fully electric property" may show more carbon emissions than the "existing property" in the current electricity grid scenario because the national electricity grid currently relies largely on fossil fuels. The chart assumes the same energy consumption as the existing property and national average grid emissions; it does not take into account the higher efficiencies achievable with electric equipment or the wide range of carbon intensities among regional electricity grids. This short-term rise in emissions may be accurate for properties with local grids heavily reliant on fossil fuels (such as coal) but will be less relevant as the grid gets cleaner and can be mitigated with highly efficient electric equipment and renewable power sources (such as on-site solar).
